Street Address, City, ST ZIP File No.: CC-55-EIFS-Stucco-SV-XXXXXX

Company: Cliff Kapson Consulting, LLC Inspector: XXXXXXX

Date of Inspection:	2/5/2015
Time of Inspection:	10:00 AM
Weather/Temp:	Sunny/30°F

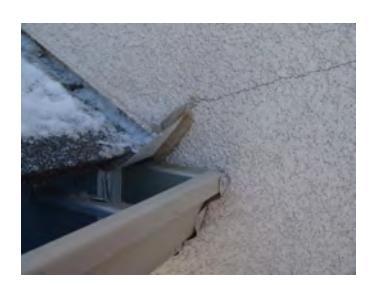
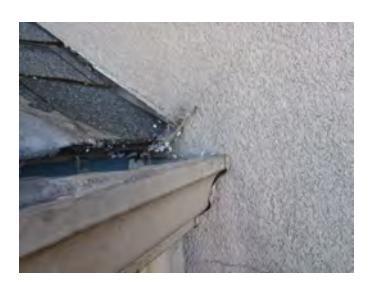
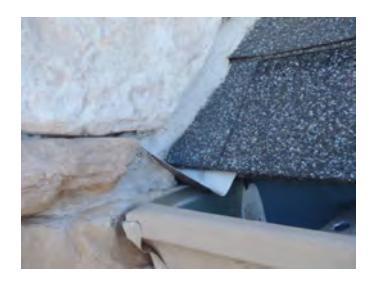
Improper Kickout Flashing

Evaluation and/or Description of Problem: Kickout flashing is improperly installed and/or sealed at roof/wall intersection as depicted in the attached photos.

Although other kickouts are improperly installed, moisture probing did not reveal any elevated moisture readings.

Properly install and seal new kickout flashing at all roof wall intersections per stucco and stone industry standards (see attached details).

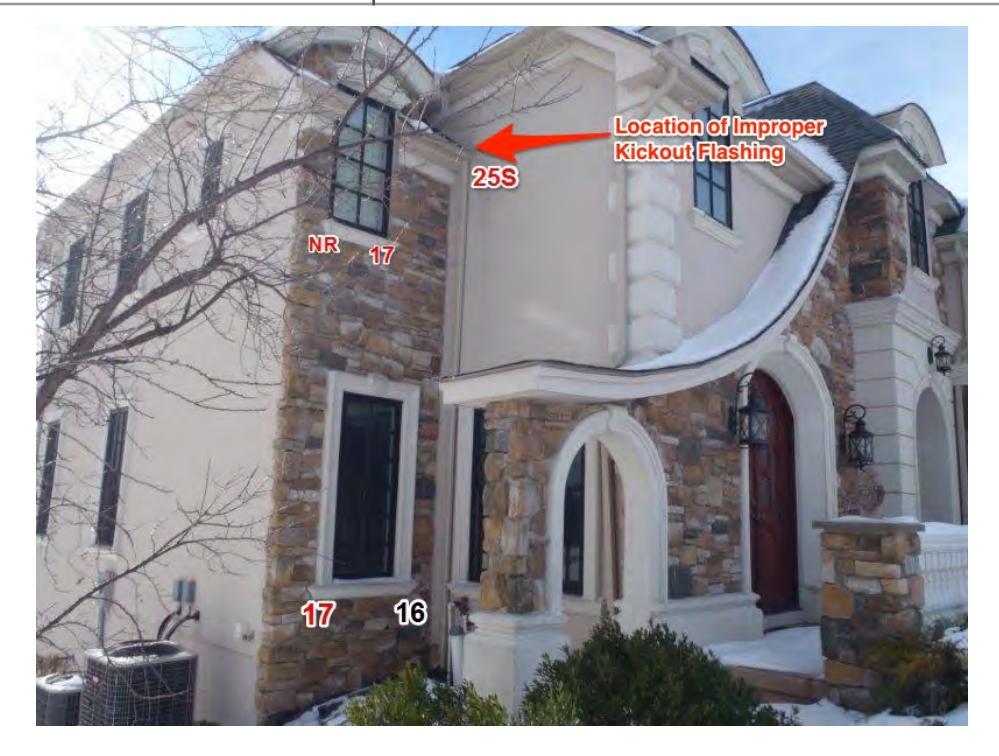
Mositure probing beneath improper kickout flashing revealed elevated moisture readings with soft substrate. These readings are depicted in the photo(s) on the following page(s). See the attached document titled "Understanding Moisture Readings" for further information.

Moisture probing through stucco, beneath improper kickout flashing on front left elevation revealed elevated moisture (25%) and soft substrate (NR Indicates No Reading)

In areas where the moisture detected exceeds 29% and/or where soft substrate is detected during probing, additional hidden damage to substrate and/or framing may exist. (See attached document "Understanding Moisture Readings" for more details.)

Remove the stucco below improper kickout location on front left elevation where moisture readings are in excess of 29% and/or the substrate is soft to allow the inspection and repair of the damaged substrate and affected structural members. (See attached document "Understanding Moisture Readings" for further detail.)

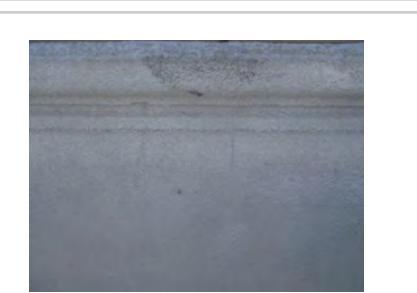
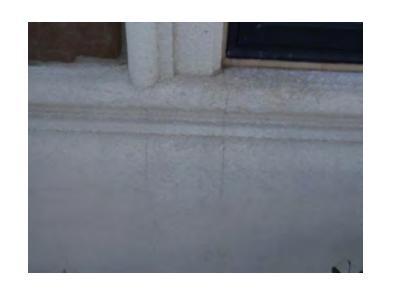
Hairline cracks in EIFS under garage windows

Harline cracks under garage windows

Evaluation and/or Description of Problem: Hairline cracking was noted beneath garage windows as depicted in the attached photos.

Cracking can occur in EIF systems for various reasons. It is usually related to the absence of proper expansion or isolation joints, or the misapplication or omission of reinforcing mesh, as required in the manufacturer's installation details.

Moisture probing Below garage windows revealed acceptable moisture readings and firm substrate.

Small cracks such as these, less than 1/32" (approximately the width of a dime) can be bridged with an elastomeric coating per manufacturer's recommendations.

All larger compression cracking should be repaired by grinding back the finish coat to the base coat; installing reinforcing mesh to bridge the crack, overlapping a minimum 2" and refinishing wall to match.

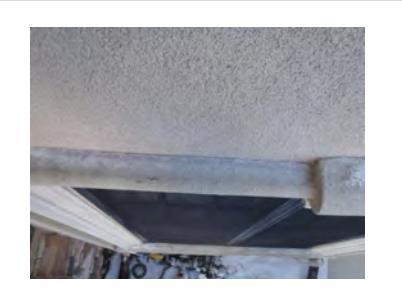
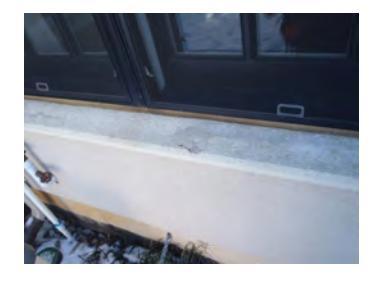
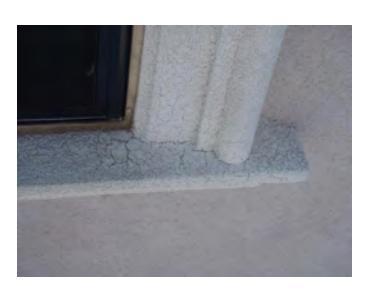
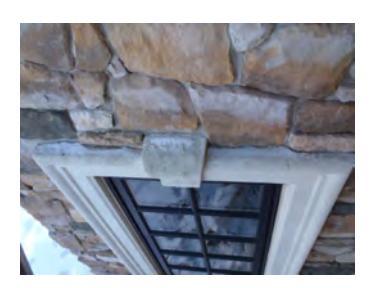
Flat EIFS details above windows with delamination

Delamination of sill on EIFS Detail

Cracks and delamination of window detail sill

Flat sill with delamination

Evaluation and/or Description of Problem: Finish coat delamination was noted at several locations as depicted in the attached photos.

In addition to flat detailing, other common causes include: (a) applying the finish under temperatures that are too low, (below the recommended 40F), (b) contamination of the base coat that may inhibit adhesives, or (c) adding fillers to the finish that dilutes it (water, sand, etc.).

Repair contractor should identify all areas of finish coat delamination and repair, as follows.

Using a power washer, remove the existing loose finish to expose the base coat layer. Some areas of finish may be difficult to remove. These areas should be thoroughly saturated with hot water until soft, and then scrape away finish with margin trowel or similar tool. Apply a "skim coat" of base over the existing finish to smooth it out, allow the base coat to cure, and apply a new finish coat to match the existing finish.

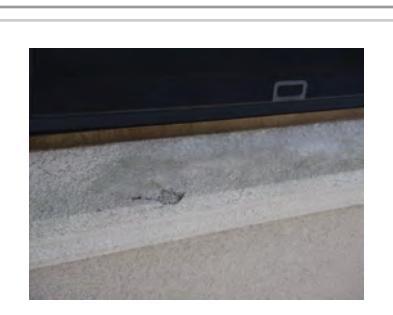
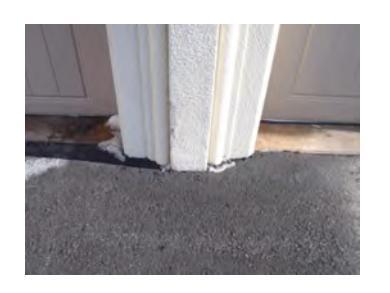
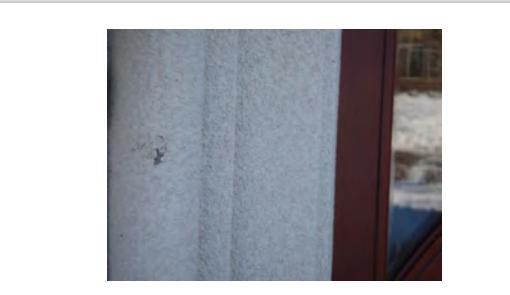
Impact damage to EIFS sill

Impact damage by garage doors

Impact damage by front door

Physical damage was noted at several locations as depicted in the attached photos. This damage is <u>not</u> considered to be the result of improper application of the EIFS or a defect in the product materials, and no moisture intrusion was detected as a result of this damage.

All areas of impact damage should be identified and repaired per EIFS industry recommended repair details to prevent long-term exposure of the system to outside elements.

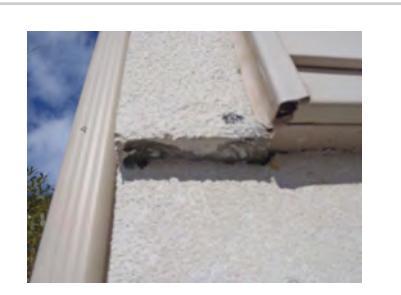
Inadequate Base Coat @ Base of System

Additionally, inadequate base coat application at system termination at grade was observed in some locations. Fiberglass mesh should be fully encapsulated in base coat.

Additionally, repair contractor should inspect entire perimeter of system at grade, and properly base coat system termination where necessary.

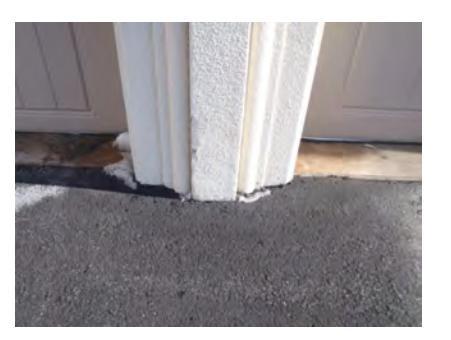
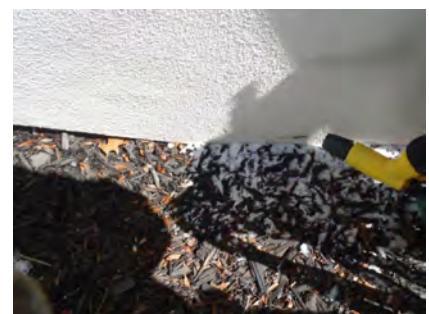
EIF system is in close proximity to grade as depicted in the attached photos. Experience data has shown EIFS in contact with grade provides means of conveyance for moisture and wood-destroying insect egress to the structure.

Improper Termination @ Grade

At all locations where EIFS is in contact with landscaping materials, remove mulch and soil so that EIF system is at an elevation at least 4-8 inches above finish grade.

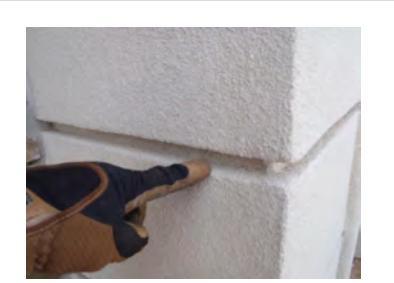
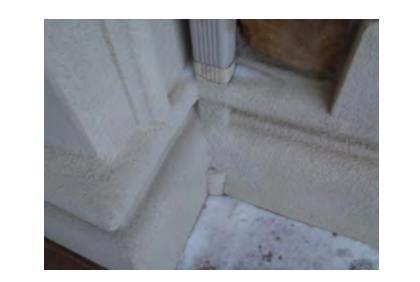
Flat surface of Quoins

Flat surface on entire front detail

Decorative details are not properly sloped as depicted in the attached photos. Manufacturers of water-managed EIF systems require all decorative details to be sloped at a minimum 3:12 pitch. When EIFS details are improperly sloped, the system is susceptible to shelving of water, especially snow and ice in winter months, which can cause moisture intrusion and finish coat delamination.

Repair contractor should apply a polymer-based, waterproof base coat (such as Dryvit Dryflex) over existing finish. Then apply the new finish to seal system and prevent finish coat delamination and/or caulk along tops of decorative details where detail meets EIFS wall to prevent moisture intrusion.

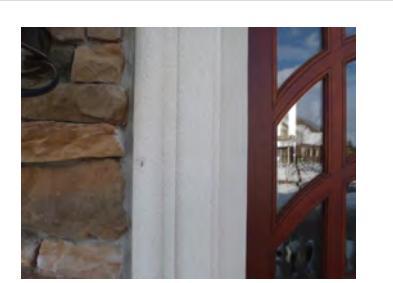
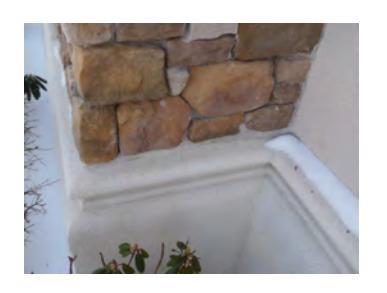
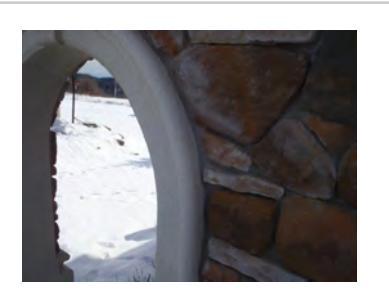
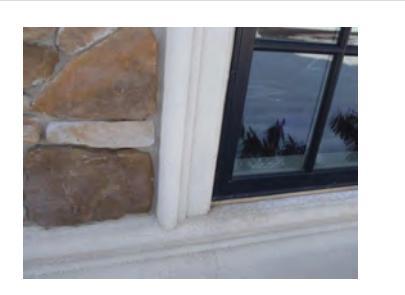
Stone Intersection w/EIFS

Stone Intersection w/Stucco

Stone Intersection w/EIFS Detail

Mortar joints present at EIFS and stucco intersections with stone as depicted in the attached photos. No sealant, backer rod, or bond breaker of any type present.

EIFS and stucco industry details require a minimum 1/2" - 5/8" caulk joint with a closed-cell backer rod and sealant at all stone intersections with dissimilar materials.

Apply bond breaker tape or triangular backer rod along EIFS/stone intersections, and then apply a fillet bead of approved sealant over the bond breaker (Note: There should be enough bearing area on each adjoining surface to adhere a minimum 1/4 inch width of sealant to each surface).

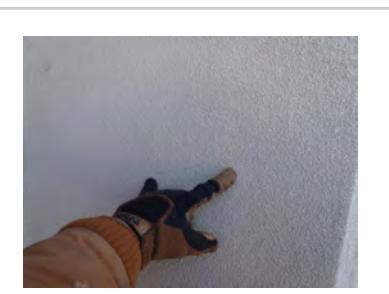
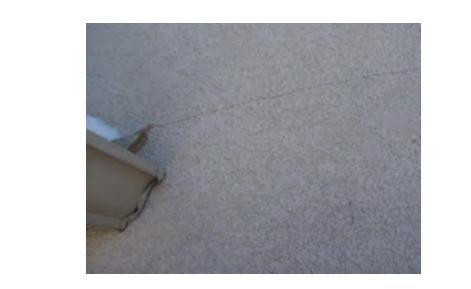
Hairline Cracking in Stucco

Evaluation and/or Description of Problem: Hairline cracking was noted as depicted in the attached photos.

Cracking can occur in stucco systems for various reasons, usually related to the absence of proper control joints.

Cracking should be repaired using the following industry guidelines.

Small structural cracks, less than 1/32" (approximately the width of a dime) can be bridged with an elastomeric coating. General application guide is 12-14 wet mil thickness per coat. Coating should be applied up to an architectural break or to the full elevation as necessary to obtain a satisfactory aesthetic appearance.

Larger structural cracks should be repaired per stucco industry standards as follows: Embed glass fiber reinforcing mesh in acrylic base coat. Overlay cracks individually with a 4-6 inch wide strip of mesh centered over the crack. If cracks are prevalent throughout an area, treat the whole area with mesh. Overlap all mesh seams minimum 2¹/₂". Resurface up to an architectural break or resurface the full elevation as necessary to obtain a satisfactory aesthetic appearance.

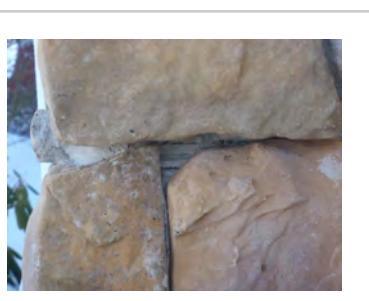
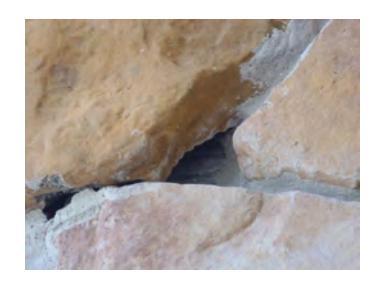
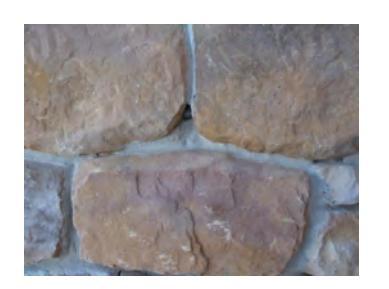
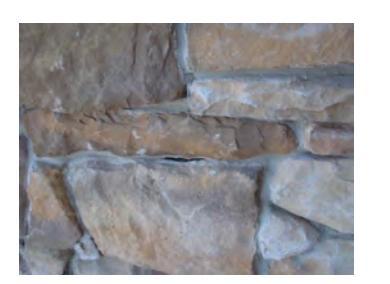
Lack of Mortar Between Stone Units

Cracking Through Mortar Joints

Several locations were observed where mortar joints have failed or there is a lack of mortar between stone masonry units. This deterioration does not appear to be the result of a system failure, but rather an original construction defect or maintenance issue. No evidence of moisture intrusion was observed as a result of the areas of failure.

Tuck pointing should be performed according to Masonry Industry Standards. Contractor should grind out areas of failing mortar, cutting down mortar to a minimum of ½" or to solid mortar, and install new mortar joints. Care must be taken in specifying compatible replacement mortar. Contractor should attempt to match new mortar to existing for pointing and repair, and be cautious about lime content of existing mortar. Consider testing existing mortar to facilitate specifying compatible new mortar. Pointing mortar should be pre-hydrated and of low cement content.

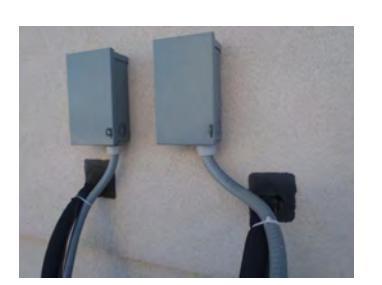
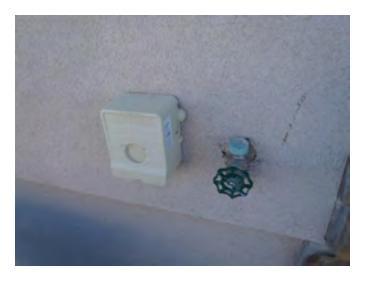
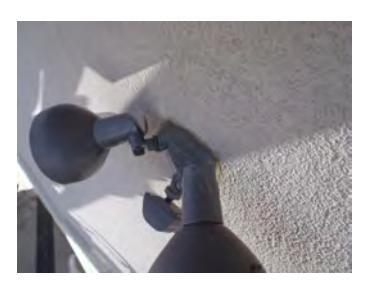
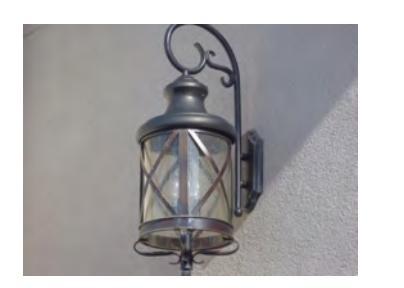
AC disconnect improperly attached

Water meter & hose bibb improperly attached

Improper light fixture attachment

Evaluation and/or Description of Problem: Attachments and/or penetrations are not adequately sealed as depicted in the attached photos.

All system penetrations such as light fixtures, electrical outlets, and utility conduit or utility boxes should be properly attached and/or sealed with an approved sealant regardless of the cladding, to prevent moisture penetration.

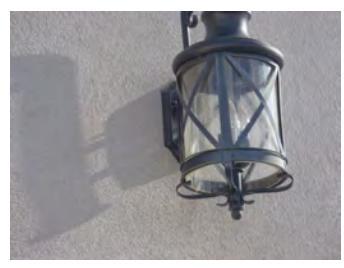
Improper light fixture attachment

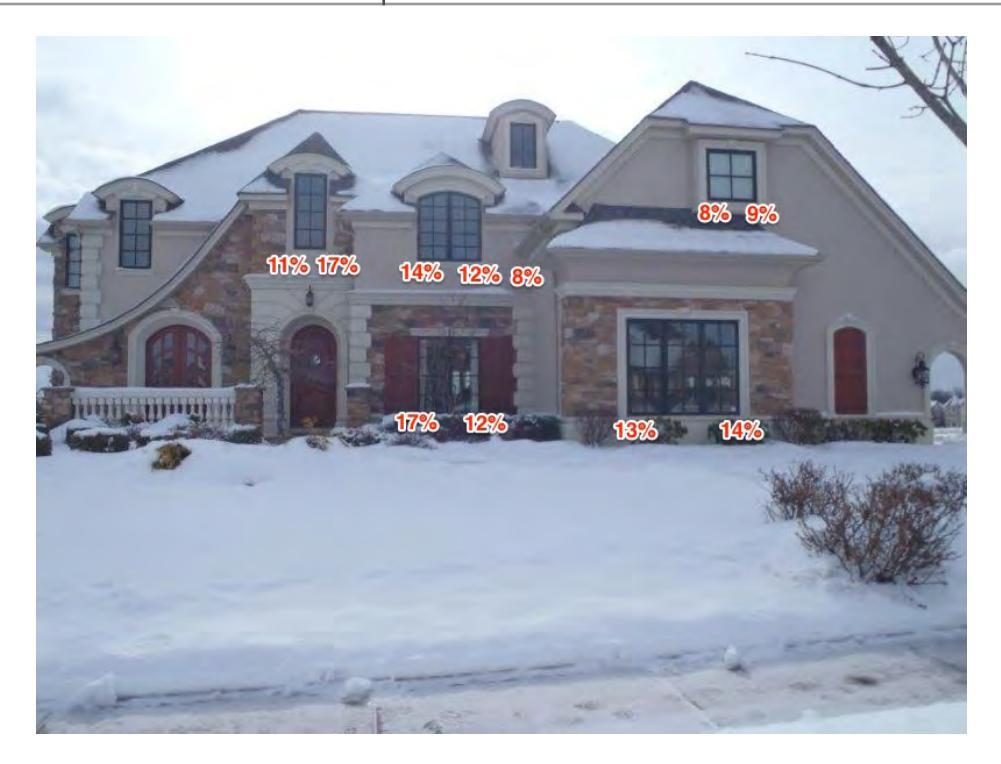
Moisture probing beneath windows revealed acceptable moisture readings and firm substrate.

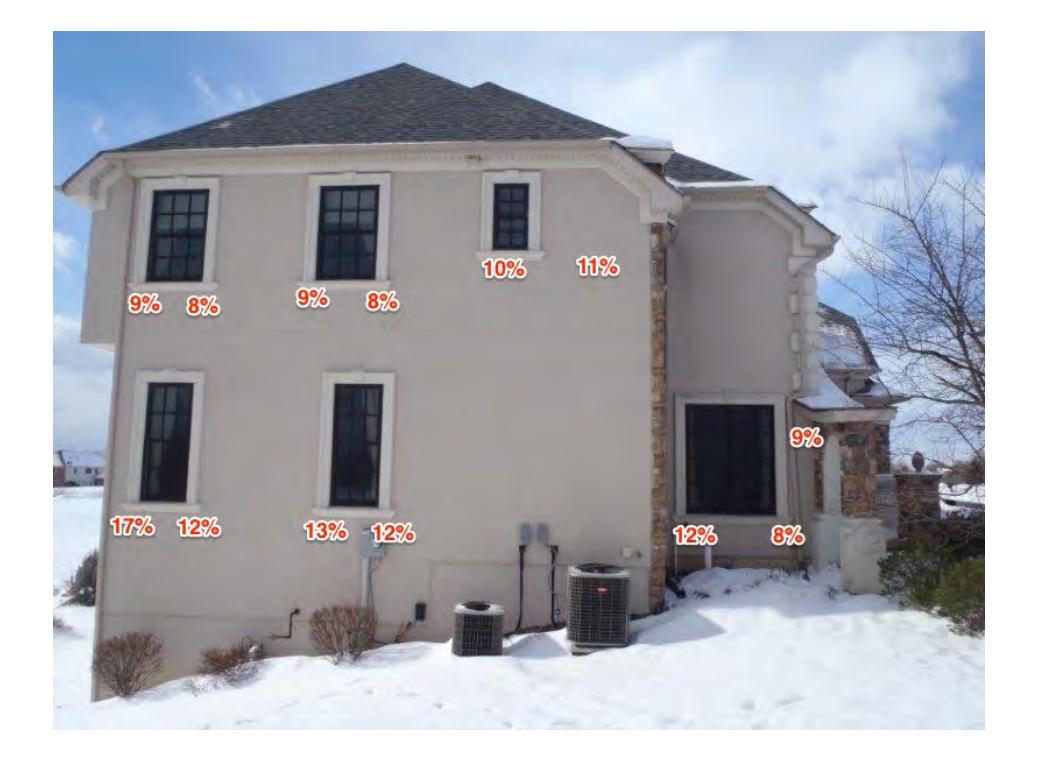
Moisture probing beneath windows revealed acceptable moisture readings and firm substrate.

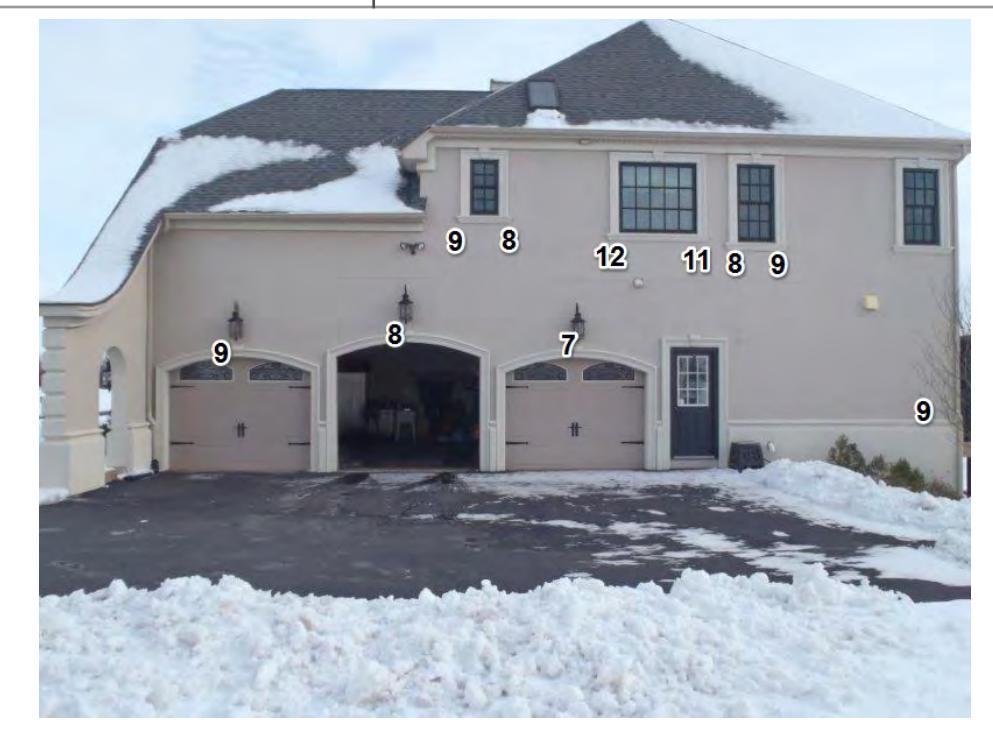
Moisture probing beneath windows and above garage doors revealed acceptable moisture readings and firm substrate.
