Stone Veneer Siding

**The Problems and the Impact
on the Relocation Industry**

David B. Russ, CRP, and Cliff Kapson

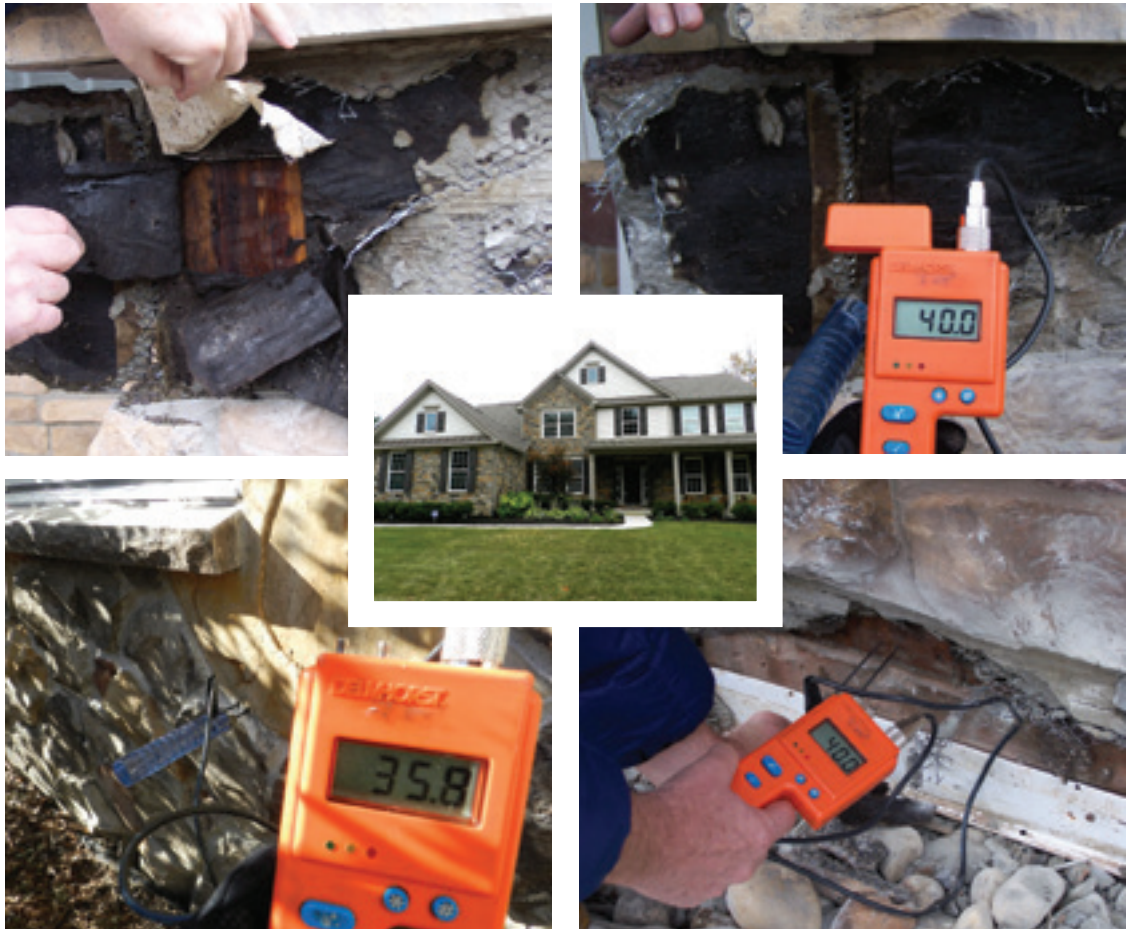
Center: Typical stone veneer; clockwise from upper left: moisture damage behind veneer; moisture probe after removal of veneer; moisture probe at veneer mortar; moisture probe and damage at grade (Photos courtesy of Cliff Kapson)

The American Concrete Institute defines adhered veneer as “masonry veneer secured to and supported by the backing/substrate—which is usually plywood or oriented strand board (OSB) sheathing—through adhesion.” Anchored veneer is defined as “masonry veneer secured to and supported laterally by the backing through anchors and supported vertically by the foundation or other structural elements” (see photos on page 110).

Moisture probing requires drilling a hole through the mortar in areas where moisture is typically found, where there is visible evidence such as staining, and/or where there are signs of improper or missing installation components. These holes are typically 3/16 to 1/8 inch in diameter. A moisture meter probe is inserted into them to detect the level of moisture behind the veneer.

Elevated moisture readings can be an indication of damage to the underlying substrate and framing. When drilling the holes for the probe, the technician may also detect soft wood on the drill bit, which further substantiates that the underlying substrate and framing have been affected.
